RefGen 1V4 Install IC9100

The RefGen module provides 32MHz reference to the IC9100 PLL circuits when driven with a 10MHz signal of 0dBm or more. When the 10MHz signal is not available the RefGen is muted and the IC9100's internal reference CR-893 is powered. The supply to the RefGen MUST not exceed 3.5 volts

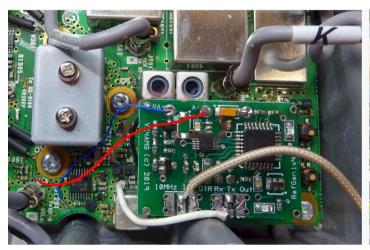
The photo below show the RefGen installed into an Icom IC9100. The red wire is connected to +V on the RefGen and the blue to +V Ref. The white connects to the Out of the RefGen output.

The module may be mounted on pigtails through each corner and soldered to the PLL shield or by double sided tape. A 60W temp controlled iron may need a supplementary heat source to solder to the tinplate. If the double-sided tape option is used one pigtail should be fitted to provide the ground / supply common connection for the RefGen.

The 10MHz signal is fed from the rear panel connector to the 10MHz pads on the RefGen.

Test the operation of the module before reassembling the radio. The green LED will light when the radio is powered. When the 10MHz is applied the yellow LED will indicate the RefGen is supplying the 32MHz refence to the radio. Refit and test the UX-9100 module. Replace covers.
